RESEARCH ON THE JOINTLESS RETROFIT OF MULTI-SPAN SIMPLY SUPPORTED HOLLOW SLAB BRIDGE

Shili bridge, built in 1995 and located on No.503 county road, Shili village, Changtai County, Zhangzhou city, Fujian province, is 111.85 m long with 6-spans of simply-supported hollow slab beams and continuous deck (Fig.1). It consists of an old bridge and a new bridge, separated by a median between them (Fig. 2). Its total width is 26.85 m, of which 9.5 m is the left traffic lane of the old bridge. The original traffic design load is Truck-20 and Tractor trailer-100. The deck pavement is cementitious concrete. The superstructure is of precast C30 concrete hollow slab beam, and the substructure is of stone gravity-pier with spread foundation. As traffic volume and overloading vehicle continuously increase, longitudinal and transverse cracks, with the widest width of 1.2 mm, appear in the left part of the bridge. Therefore, it is urgent to take technical inspection and then carry out corresponding strengthening measures for the left bridge.

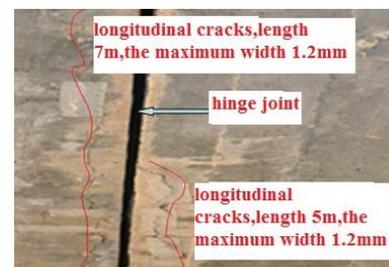
Figure. 4. Cracks on the bottom of beam

1) Longitudinal cracks appear on top of bridge deck and bottom of slab beam near hinged joint, with the maximum width of 1.2 mm (Figs.3-4). Meanwhile, transverse cracks appear on bridge deck over pier, with the maximum width of 1 mm (Fig.3). Besides, concrete spalling, corner-missing and bare steel also appear along hinged joints (Fig.5).

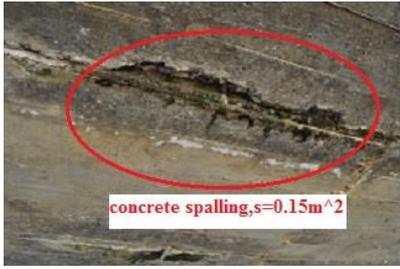
Figure.5. Concrete spalling

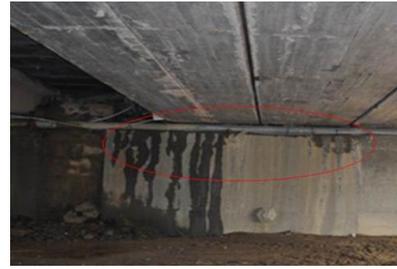
Figure. 6. Water seepage

2) Abutments and piers are in nearly good condition with no visible displacement, settlement and cracking, and the only noticeable distress is the serious water seepage (Fig.6).

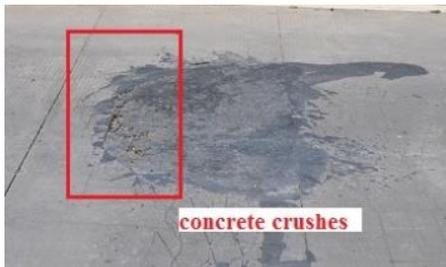
Figure.7 Pavement concrete crushing

3) Pavement concrete is crushed seriously (Fig.7). Besides, most EPS-bearing layers are damaged so that beam bottoms are in tight contact with the bent caps supporting them (Fig.8). Expansion joints don't go through the sidewalk slabs and the rails, which leads to the blockage of longitudinal thermal deformation. Consequently, in part of the sidewalk slabs have appeared transverse continuous seams. Meanwhile, most of the deck drain pipes have failed to function, which causes serious ponding on the bridge deck (Fig.9).

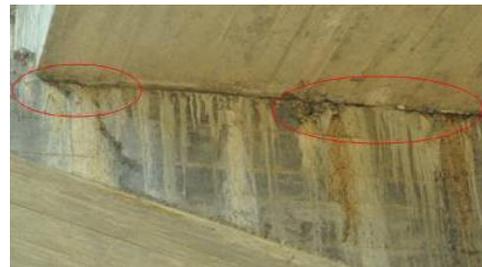
Figure.8 Tight contact between slab bottom and bent cap

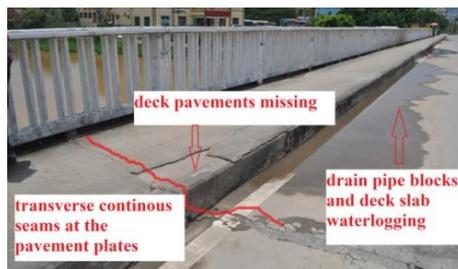
Figure.9. Rupture of bridge deck and side walk pavement
